BLACKBERRY HAY FARM DAM
JASPER COUNTY, MISSOURI
MO 20196

PHASE 1 INSPECTION REPORT NATIONAL DAM SAFETY PROGRAM

BLACKBERRY HAY FARM DAM
JASPER COUNTY, MISSOURI
MISSOURI INVENTORY NO. 20196

Name of Dam: Blackberry Hay Farm Dam
State Located: Missouri
County Located: Jasper County
Stream: Pond Creek
Date of Inspection: 20 June 1979

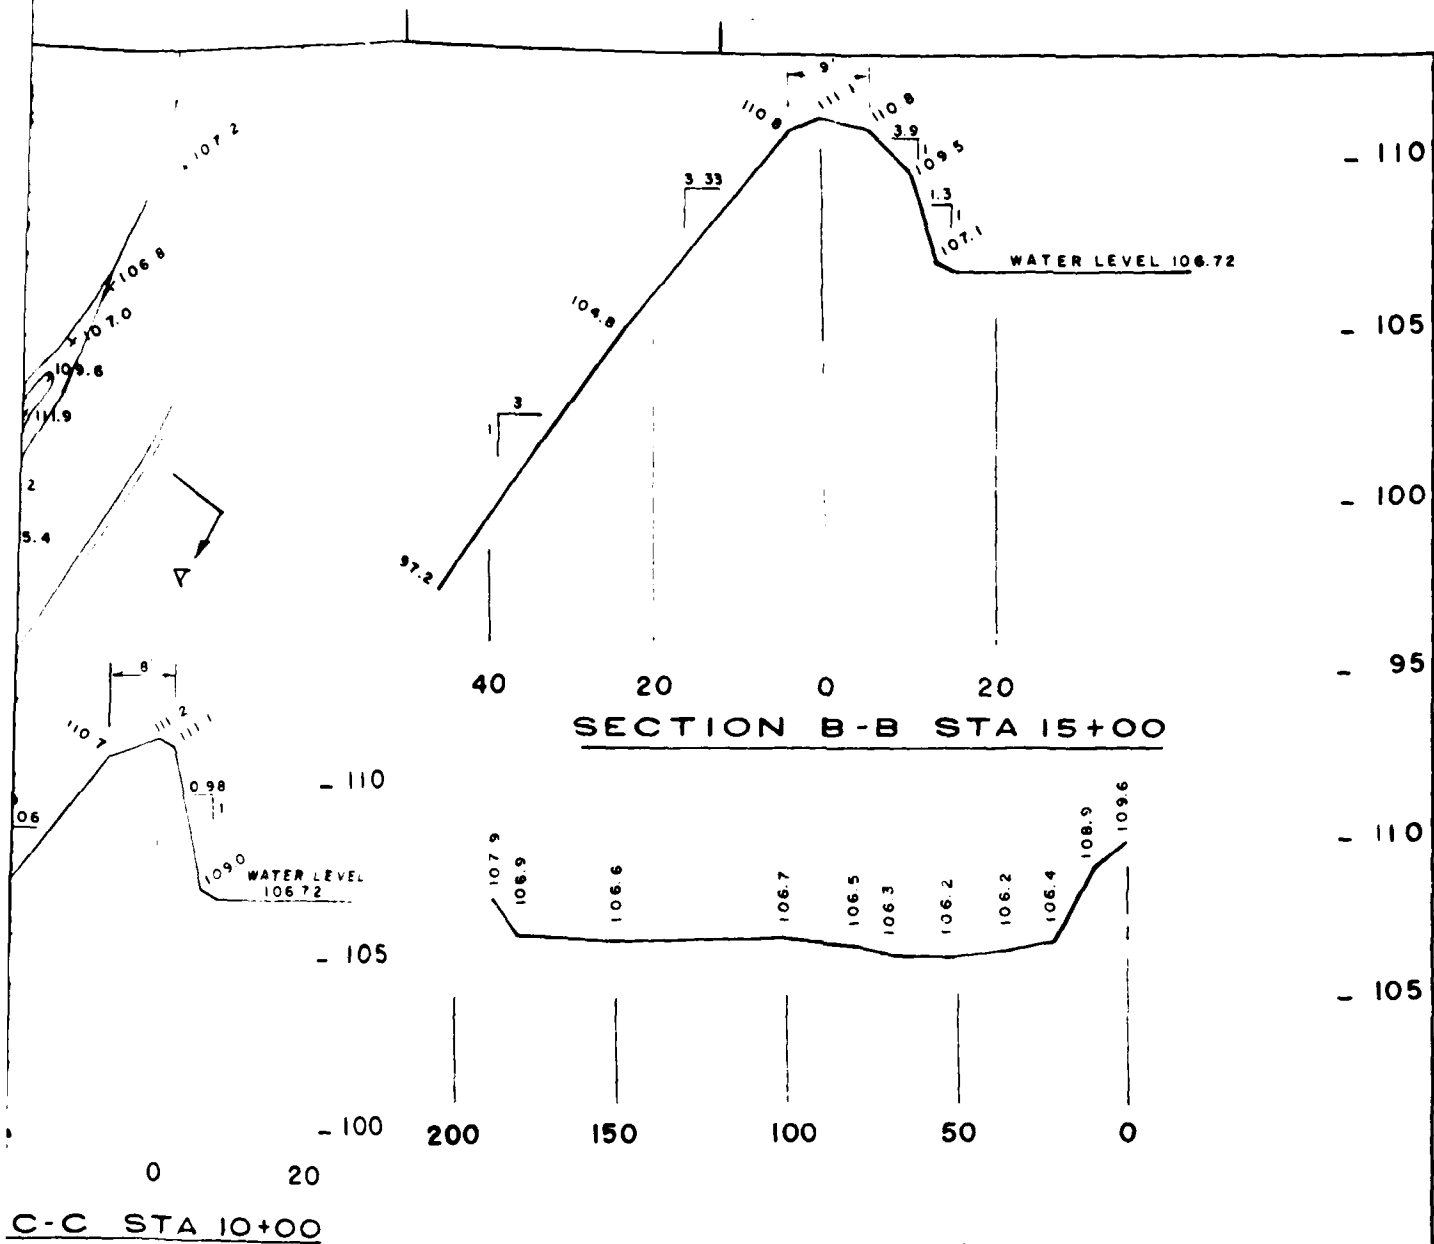
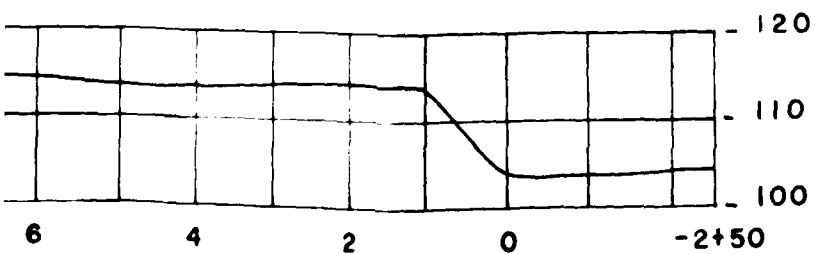
Blackberry Hay Farm Dam is an earth fill structure approximately 20 ft. high and 2900 ft. long at the crest. The appurtenant works consist of earth lined overflow spillways in the north and west abutments. Two 8 inch diameter steel pipes are provided at Stas. 15+00 and 17+00 to drain the lake. Sheet 3 of Appendix A shows a plan, profile and typical section of the embankment.

Pertinent data about the dam, appurtenant works, and reservoir are presented in the following paragraphs. Sheet 3 of Appendix A presents a plan, profile and typical section of the embankment.

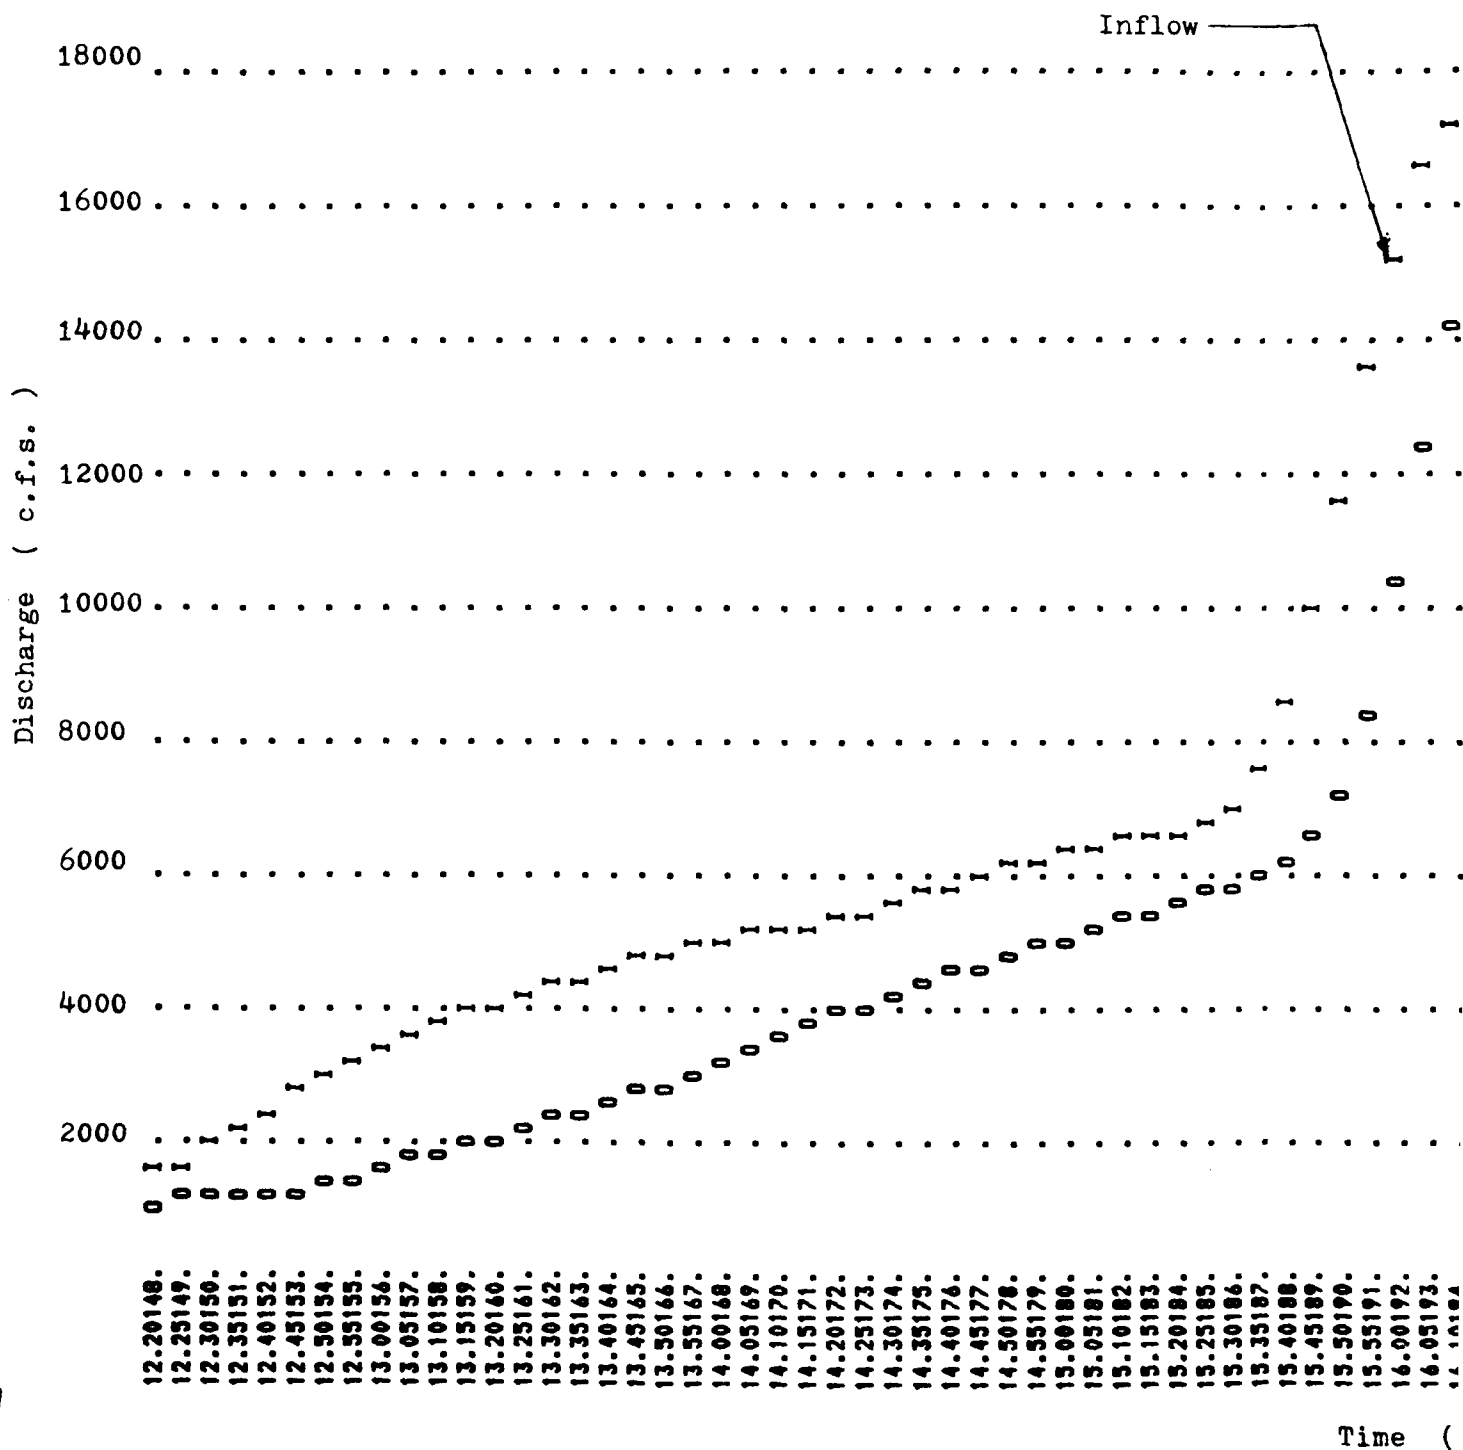
INFLOW - OUTFLOW
HYDROGRAPH
FOR 100% P. M. F.

Based on our analyses, the combined spillways will pass 60 percent of the Probable Maximum Flood (PMF). The Probable Maximum Flood is defined as the flood discharge that may be expected from the most severe combination of critical meteorologic and hydrologic conditions that are reasonably possible in the region. The recommended guidelines from the Department of the Army, Office of the Chief of Engineers, require that the structure (intermediate size with high downstream hazard potential) pass the PMF, without overtopping.

Max. Inflow = 17,285 c.f.s.

Max. Outflow = 16,375 c.f.s.
